A Collaboration of Statistics and Engineers Without Borders: Health and Water Survey in Belize

The Texas A&M University chapter of Engineers Without Borders (EWB-TAMU) conducted a comprehensive analysis of health conditions and water quality in the community of San Mateo, Belize. Statistics Without Borders (SWB) was contacted to aid in the appropriate evaluation and reporting of data. This paper describes the project with some of the findings, as well as the collaboration between the two volunteer organizations and the challenges encountered.

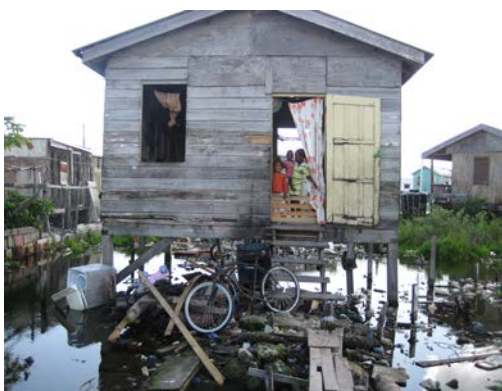
Figure 1: Typical San Mateo residence

frequently inundated by minor storms. The area is characterized by extreme poverty, inadequate housing as well as sewage and water supply infrastructure. A photograph of one of the residences is provided in Figure 1. In addition, the poor drainage results in standing water that is frequently contaminated with sewage. Many residents must utilize substandard wooden pedestrian bridges (Figure 2) that are in constant state of near collapse (locally referred to a ‘London Bridge’ because they all fall down). Disease bearing mosquitoes are a constant issue as well. As a result the residents of San Mateo are at risk to water born diseases.

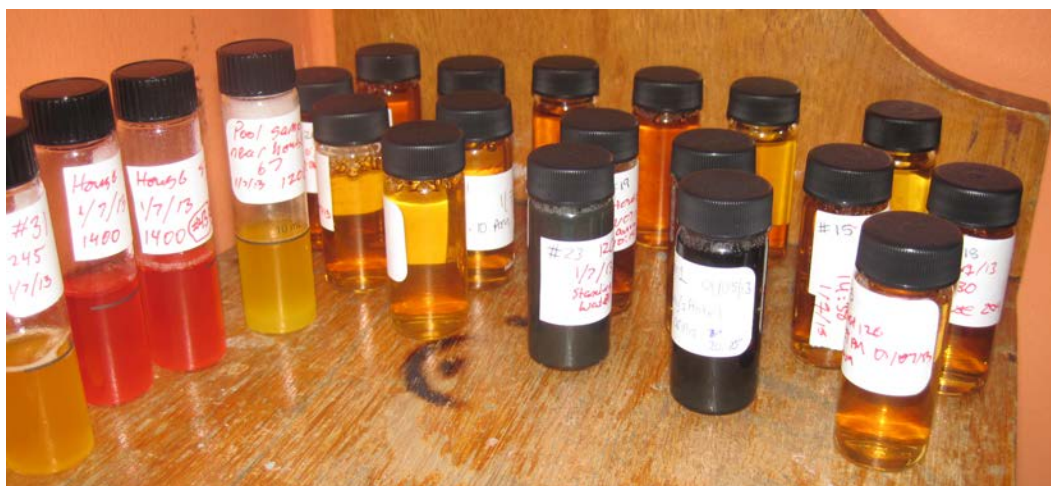
Figure 3: Samples undergoing evaluation during study.

Water is tested for coliform bacteria (both hazardous and benign) using several different types of tests. A photograph of some of these samples being evaluated is shown in Figure 3. Appropriate use of these techniques requires a firm understanding of sampling protocols. Training of team members was conducted prior to collecting samples and several spot checks were made to assure a minimal sampling error.

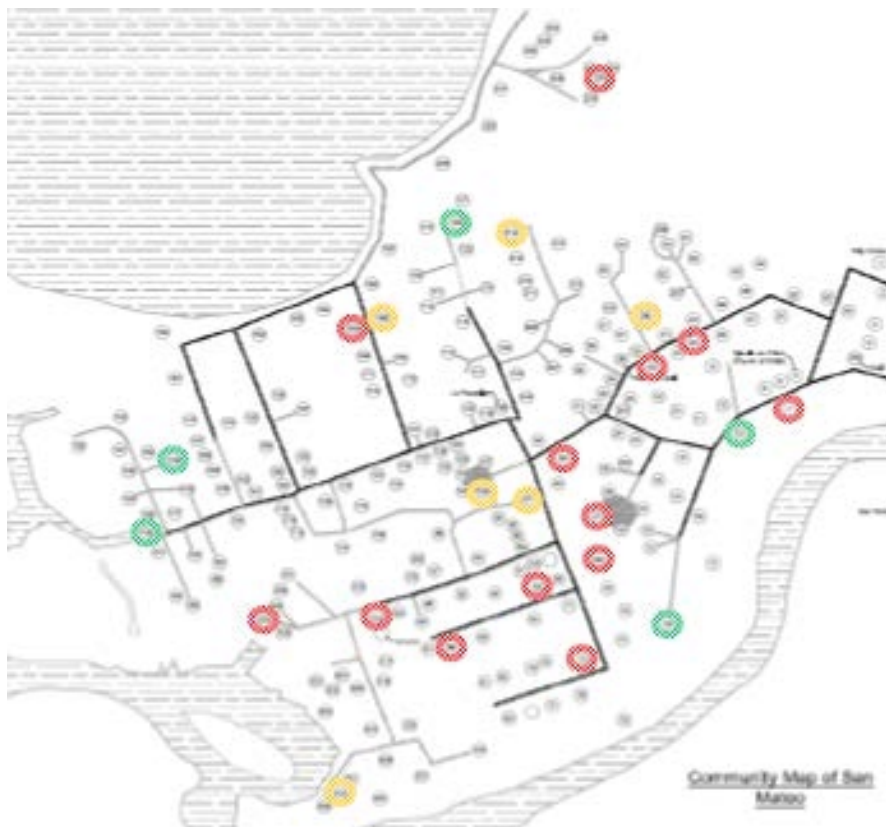
**Figure 5:** Risk Assessment rating of homes assessed.**Table 5:** Summary of Health/WQ Assessments

A map of the showing identified sample locations and rated houses is provided below in Figure 5. This mapping shows that the At-Risk and Dangerous homes are uniformly distributed throughout the community. This indicates that there is not an easy fix to the health issues. A summary of the records are provided in Table 5.

While the San Mateo area is still at risk, the EWB-TAMU team made recommendations for the community to reduce water contamination (including improved sewage treatment and drainage of standing water, installation of Sawyer filters and education on the use of chlorine for household water disinfection). As well, they recommend increased health education for the community.
